Intel® Celeron® M Processor

Specification Update

August 2004

Document Number: 300303-006

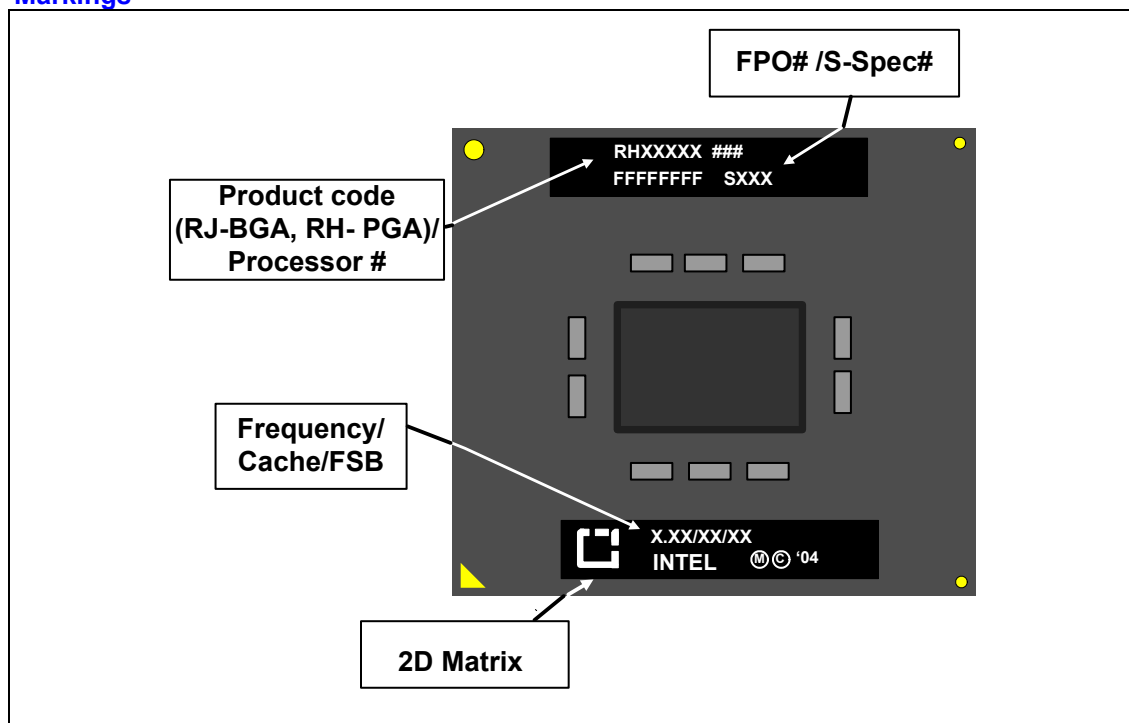
Figure 3. The Intel Celeron M Processor on 90 nm Process (Micro-FCPGA/FCBGA) S-Spec Markings
